CASE STUDIES IN FINANCING URM RETROFITS

TWO BUILDINGS: TWIN PROJECTS

The Costs of a Seattle URM Retrofit

One Yesler Way

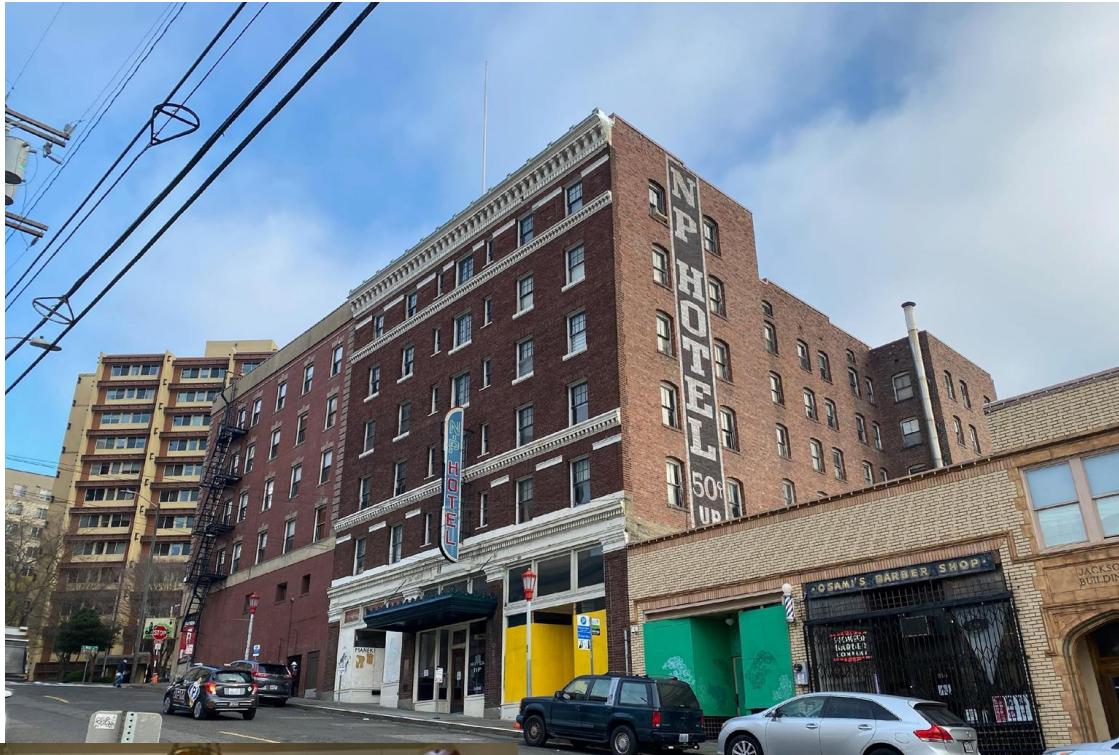
THE NP HOTEL

Interior finishes
Windows
HVAC
Elevator upgrade

2023:

- A. Add 1/2" plywood sheathing at floors 2-4. Increase nailing
- B. Add connectors at floor-to-wall connections. Verify 1993 floor-to-wall and add ties where missing or exceed 6' O.C.
- C. Add diaphragm straps near elevator
- D. Add nailing to existing plywood shear walls
- E. Add HSS tube columns at the ends of existing plywood shear walls
- F. Retrofit existing steel moment frames with new bracing
- G. Provide 2 braced frames below discontinuous north and south URM walls
- H. Provide new foundations below the new braced frames, and other bays as noted on plan
- I. Provide let-in concrete strongback beams at the exterior URM walls within the stairwells
- J. Provide HSS tube steel columns below exiting heavy timber beams, for secondary support

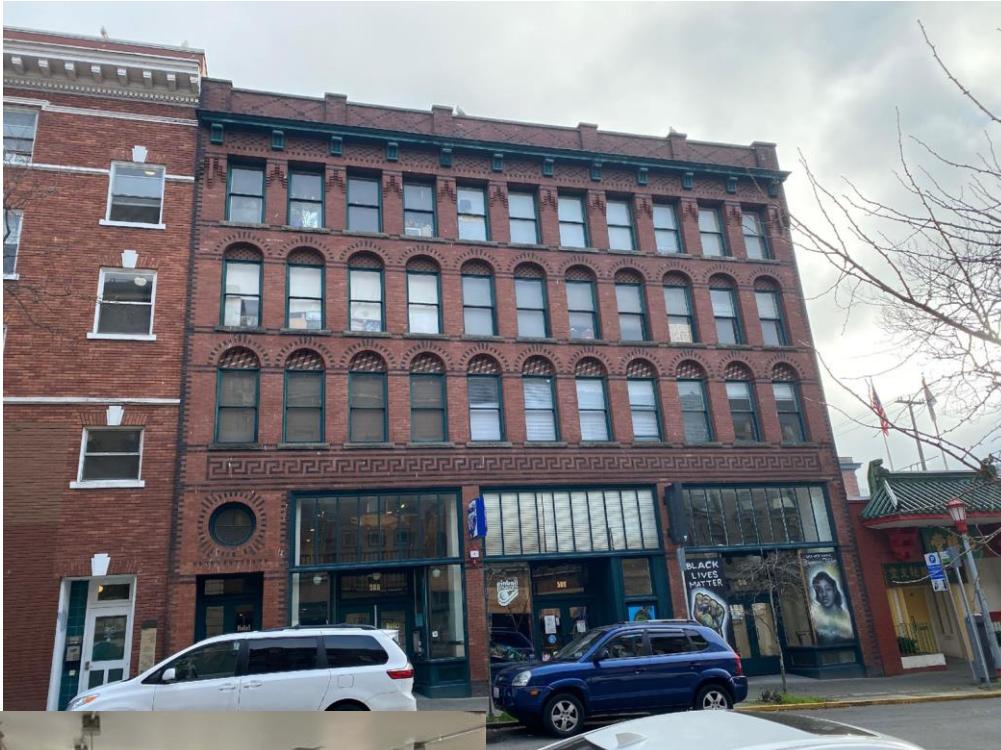
THE EASTERN HOTEL

Interior finishes
Windows
HVAC
Elevator upgrade

2023:

- A. Add continuous straps or angles at the wood floor / URM walls.
- B. Provide 6"-8" concrete wrap at all concrete moment frame columns installed in 1998.
- C. Add concrete grade beams tying the base of the wrapped columns to the existing foundations

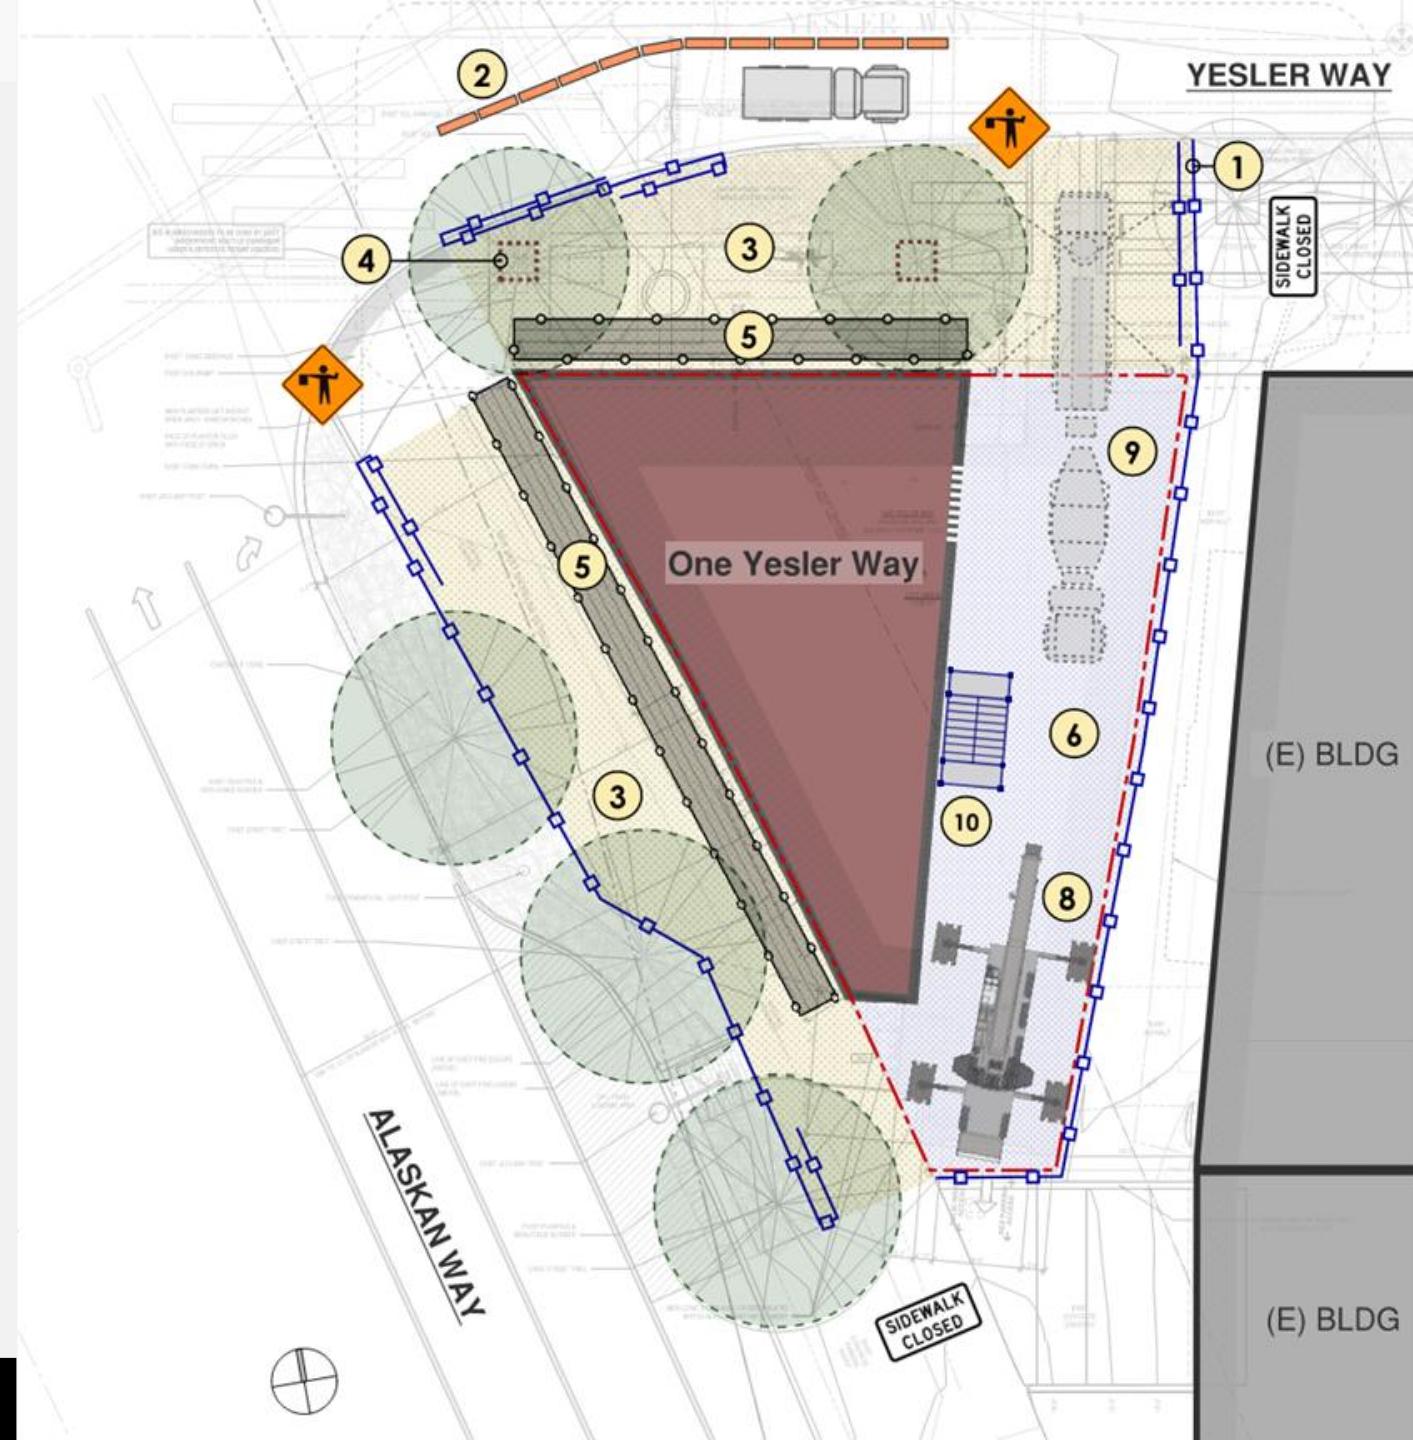
Site Logistics Keynotes

- 1 Perimeter Fencing. Secure at EOD
- 2 Jersey Barriers. Move to Curb at EOD
- 3 Extents of Sidewalk Closure shaded Yellow
- 4 Protect Street Trees within Perimeter
- 5 Scaffolding &/or Boom Lifts for Ext. Access
- 6 Undeveloped Lot = Staging/Hoisting Area
- 7 Temp Opening for Drill Rig Access. Selectively Remove & Preserve Brick.
- 8 Proposed Location for Carry Deck Crane
- 9 Proposed Loading & Pumping Location
- 10 Stair Tower for Upper Level Access

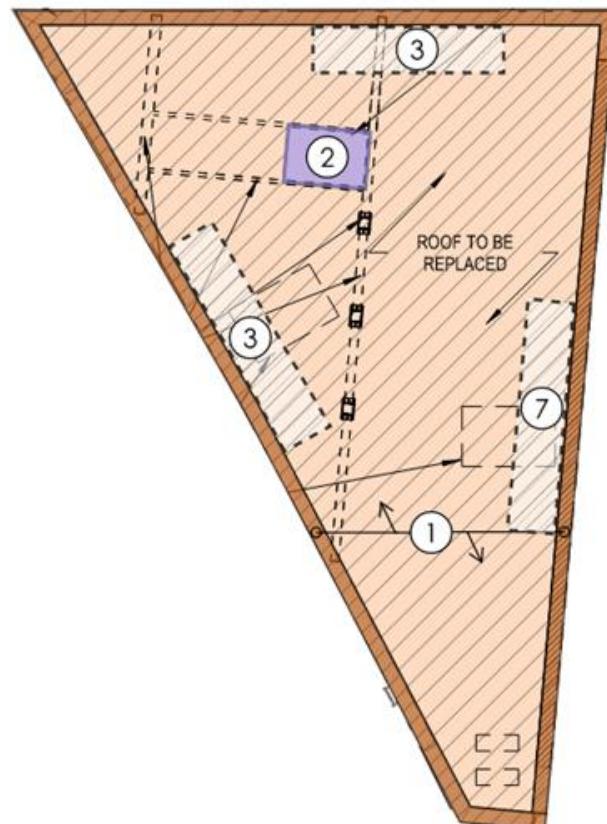
ROOF DEMO SCOPE

1. Remove Roofing & Parapet Cap for Sheathing Installation
2. Remove & Preserve Skylight for Re-installation after New Roofing Installation
3. Create Roof Openings to Place Brace Frame components.

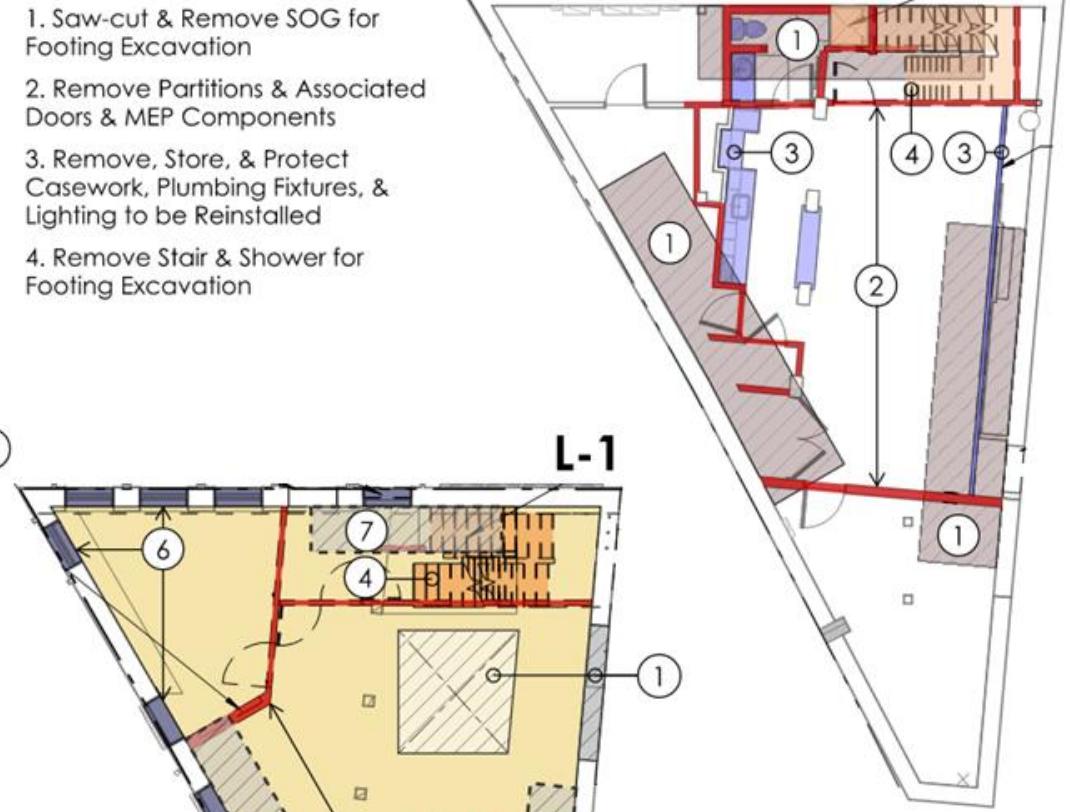
BASEMENT DEMO SCOPE

1. Saw-cut & Remove SOG for Footing Excavation
2. Remove Partitions & Associated Doors & MEP Components
3. Remove, Store, & Protect Casework, Plumbing Fixtures, & Lighting to be Reinstalled
4. Remove Stair & Shower for Footing Excavation

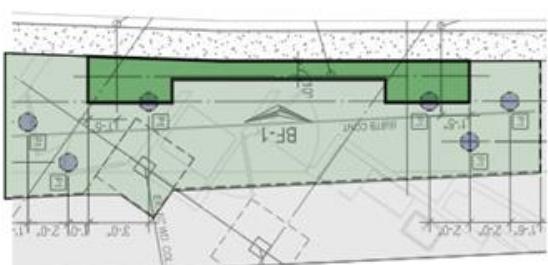
Micropiles & Foundations

MICROPILES PER PLAN

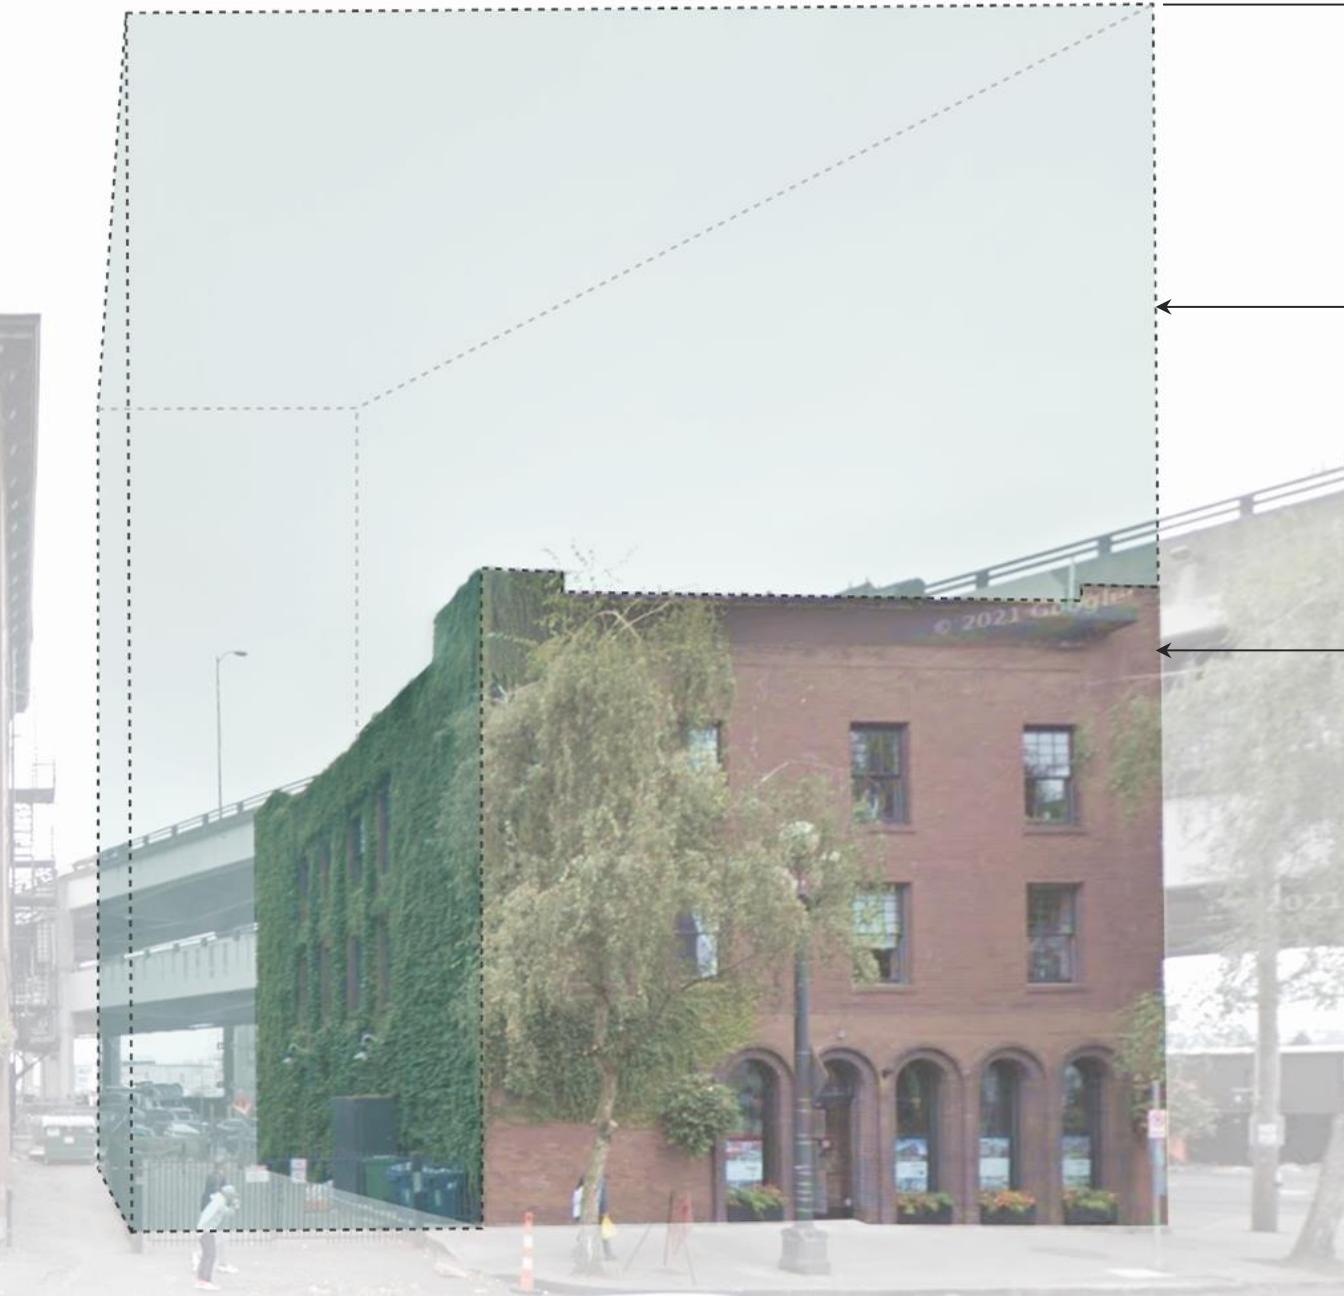
PSM Zone Height Limit Above Average Grade

100' - 0"

Unused Development Area : **21,386 SF**

Chargeable (Existing) Area: **6,181 SF**

Total Dev. Area = $3,063 \text{ SF} \times 9 \text{ Floors Max} = 27,567 \text{ SF}$

Total Dev. Area – Chargeable Area = 21,386 SF
